Stress-strain state of seepage-control wall constructed for repairs of earth rock-fill dam

M.P. Sainov, O.V. Anisimov, National Research Moscow State Civil Engineering University, Moscow, Russia	Канд. техн. наук, доцент М.П. Саинов, аспирант О.В. Анисимов, Национальный исследовательский Московский государственный строительный университет, г. Москва, Россия	
Key words: earth-rockfill dam; cut-off wall; dam failure; soil subsidence; stress-strain state; clay-cement concrete; seepage load; bored piles	Ключевые слова: каменно-земляная плотина; стена в грунте; авария плотины; просадки грунта; напряжённо-деформированное состояние; глиноцементобетон; фильтрационная нагрузка; буронабивные сваи

The study was conducted on the example of Kureyka HPP dam. Kureyka HPP earth rock-fill dam was constructed in 1980-s on the Kureyka River in Russia's Far North [14].

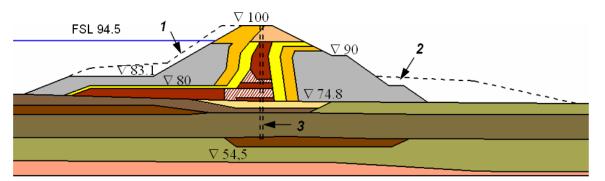
The emergency situation at Kureyka dam occurred on July 26, 1992, at its left-bank section. During failure the upstream level was 95 m, 0.5 m higher than FSL. The length of the emergency section was about 30 m (from Sta. 7+00 to Sta. 7+32). The emergency situation was created due to the sharp increase of seepage discharge (from 20 to 1750 l/s), removal by seepage flow of a considerable volume of soil, as well as subsidence of the dam upstream slope crest. Crest subsidence at the dam emergency section amounted to about 1 m [14, 15].

Figure 1. Dam configuration in the design section (Sta. 7+27) 1 – profile of fill on the upstream slope for emergency situation liquidation; 2 – profile of fill on the downstream slope; 3 – location of the seepage-control wall made for dam repairs

The design of measures on repairs of the dam emergency section envisaged construction of a wall at the section from Sta. 6+20 to Sta. 7+60. The wall was made of bored piles 1200 mm in diameter with spacing 850 mm [17, 18]. The design depth of the wall is 35 m. It cuts the about 25 m high earthfill dam body and deepens into the earth foundation for about 10 m.

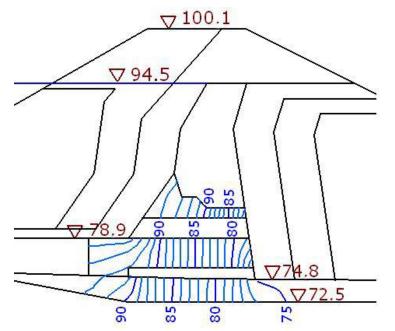
Figure 2. Location of lines of the equal level in water permeable zones of the structure during failure

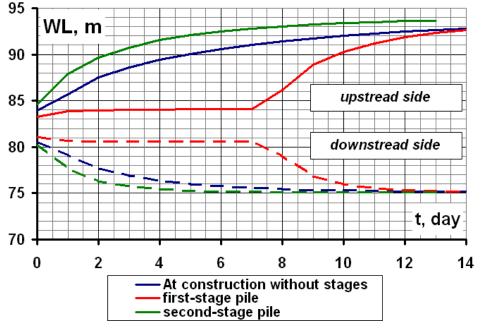
Figure 3 shows time-dependent variation of water levels around one separate pile for two construction methods of the wall¹. Water level from the pile upstream side rises, while from the downstream side it lowers.

When piles are arranged subsequently, the rate of seepage forces increase is determined by the rate of bored piles construction. At placement of one pile a day the pressure on the wall will increase faster than the rate of clay-cement concrete hardening (Fig. 3). When piles are arranged in 2 stages there appears the difference between operation conditions of the first-stage piles and the second-stage piles. The first-stage piles for durable time do not have loads from seepage flow, because it passes between them. Seepage pressure arises only when space between piles of the first stage is filled by the second-stage piles. During these several days clay-cement concrete may acquire 50–80 % of its strength. From the moment of the wall closure the pressure on piles of the first and the second stages starts to grow intensively (Fig. 3). This process is faster than that during subsequent construction.

Figure 3. Variation of seepage water levels around a pile

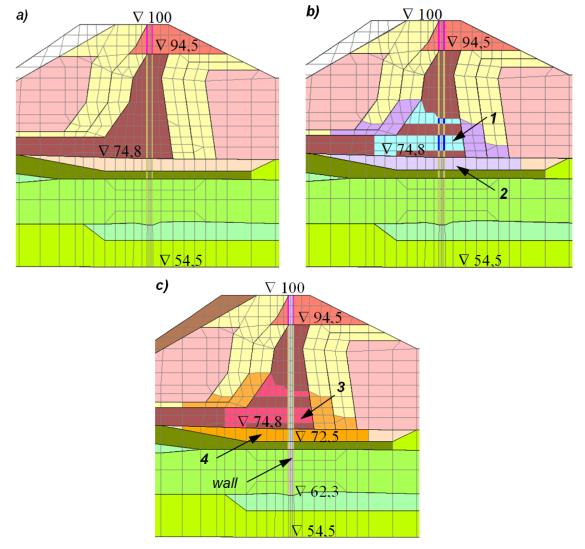
At the fourth computational stage the modeling was fulfilled of the structure SSS variation at appearance, development and liquidation in it of the emergency situation. At the first step of this stage the formation of water permeable zones was modeled: the character of water force action on the structure changed. Hydrostatic pressure on the core upstream face was replaced by seepage flow forces (spatially distributed seepage forces and seepage forces distributed on the surface). The second step modeled the failure itself, i.e. damage of the dam by seepage flow, when intensive seepage led to disturbance of soil structure and properties. In the structure model the zones were distinguished where soil subside and have increased deformation. They covered part of the core, transition zones as well as the sand layer in the dam foundation (Fig. 5b).

Figure 5. Changes in FEM mesh at various stages of computations (fragment) a – before failure; b – during failure; c – after failure, at dam construction; 1, 2 – water permeable zones and zones of subsidence, 3, 4 – zones of weakened soils

At modeling the dam failure it was assumed that the subsidence zone covers a part of the core, both transition zones as well as the sand layer under the dam (Fig. 5b). Figures 11, 12 show design displacements of the structure at development in it of subsidence zones as a result of soil damage by seepage flow.

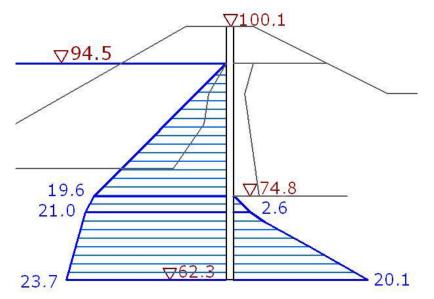
Figure 6. Design curve of seepage pressure on the pile (in m of water column)

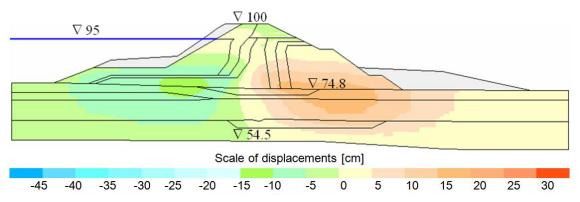
Maximum displacements also observed on the boundary between the dam and the foundation (Fig. 7). Under the upstream shell the settlements are directed toward the upstream side (maximum 14 cm). Under the downstream shell the settlements are directed toward the downstream side (16.3 cm). Settlements of shells in different directions may have resulted in separation of the apron from the core and development of a vertical joint at their contact.

Figure 7. Structure horizontal displacements occurred during construction and reservoir filling

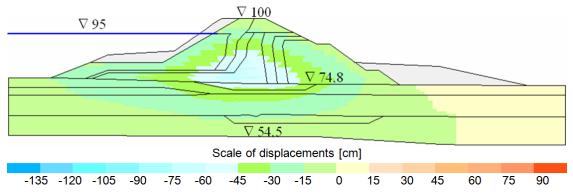
By the results of computations the dam has complicated SSS. Before development of emergency situation the dam SSS was considerably subject to soil foundation deformations. Under the dam dead weight and hydrostatic pressure on the apron the dam foundation settles and expands in both sides (Fig. 7, 8). The greatest settlements (56 cm) of foundation occurred under the apron, near the core (Fig. 8). In this zone the dam settlements also reached the maximum values (60 cm). The core settlements are more considerable than those of the shells.

Figure 8. Structure vertical displacements occurred during construction and reservoir filling

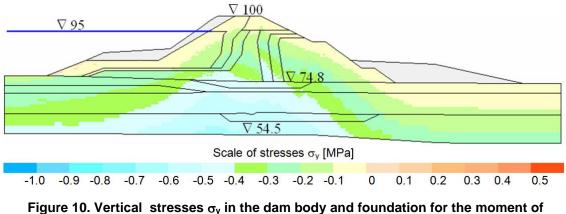
By distribution of stresses σ_y in the dam body (Fig. 10) "suspension" of the core on the shells may be noticed. In the core foundation the stresses σ_y did not exceed 0.45 MPa, while in the downstream transition zone they reached 0.75 MPa. From the upstream side the core suspends weaker, because it has some inclination toward the upstream side. Deficit of compressive stresses σ_y in the core could also cause failure.

jure 10. Vertical stresses σ_y in the dam body and foundation for the moment o construction completion and reservoir filling

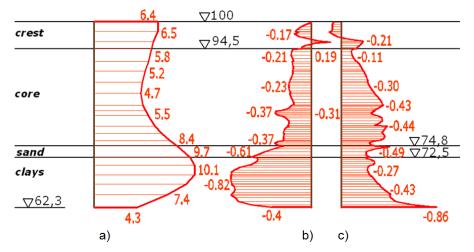
When the wall is made of clay-cement concrete the impact of bend deformations on values of stresses σ_y is weak (Fig. 15): no tensile stresses in the wall occur.

Figure 15. Stress-strain state of clay-cement concrete wall: a – horizontal displacements from seepage forces; b – vertical stresses σy on the upstream face; c – vertical stresses σy on the downstream face

The greatest compressive stresses σ_y appear on the wall foot (Fig.15). These stresses are less than clay-cement concrete compressive strength, which amounts to 1-2 MPa [18,19]. There is no danger of compressive strength failure.

5. For material of the seepage-control wall in the failed dam it is recommended to use plastic claycement concrete, which by deformability is close to the surrounding soil mass with secant modulus of deformation not exceeding 300 MPa. This permits avoiding appearance of tensile stresses in the wall. Compressive stresses in the wall will not exceed the clay-cement concrete compressive strength.

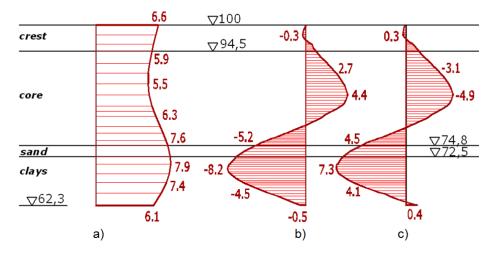
In the wall made of reinforced concrete the characteristic feature is appearance of considerable tensile stresses (Fig. 16). They are many times more than concrete tensile strength. That is why it is desirable to use the material with low deformation modulus in order to avoid cracking in the wall.

Figure 16. Stress-strain state of concrete wall: a – horizontal displacements from seepage forces; b – vertical stresses σ_y on the upstream face; c – vertical stresses σ_y on the downstream face
