Seismic stability of the restored architectural monument

V.N. Alekseenko,
O.B. Zhilenko,
*Crimean Federal University Vernadsky, Simferopol,
Crimea, Russia*

Abstract. The conservation of monument of architecture of XIX century – the Church of St. Archangel Michael in Sevastopol is discussed in the article. The analysis of the results of the survey of the building is developed and recommendations to strengthen the supporting structures of the church are worked out. The use of traditional methods for enhancing structural and seismic reinforcement of buildings with walls of masonry leads to the inevitable loss of the original facade or interior of the temple. To enhance the analysis and design of earthquake resistant walls pasted anchors performed experimental research collaboration adhesive bonding steel anchors in the stone elements from limestone Krymbalsk deposits. The proposed measures to strengthen allow performing repair and restoration work, without breaking the historical reliability of the facades. Comprehensive solutions for strengthening and ensuring of an acceptable level of safe operation in seismic areas are developed.

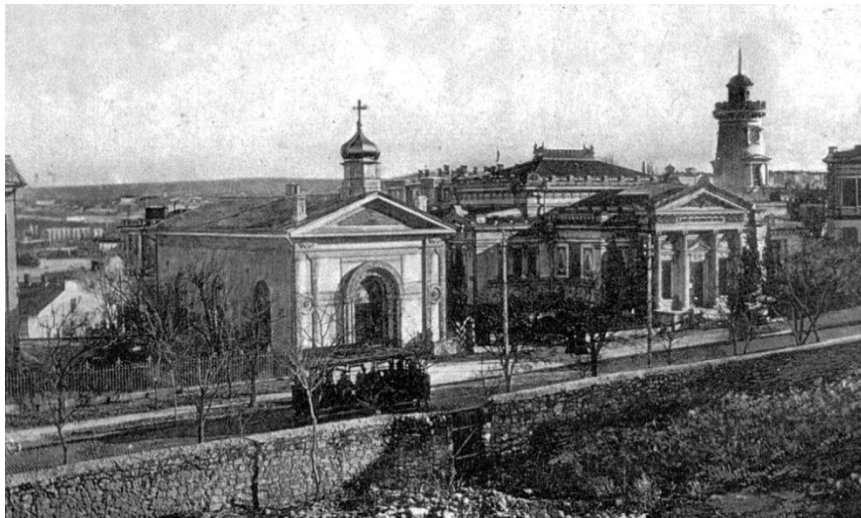
Figure 1. The Church of St. Michael the Archangel in the city of Sevastopol. Historical views

Dome is recommended to restore the original version of the dome at the western front wall as shown in Figure 1. Supporting the dome to implement the newly arranged by metal girders. Dome must be performed with metal-plating carcass of vertical walls with light modern materials.

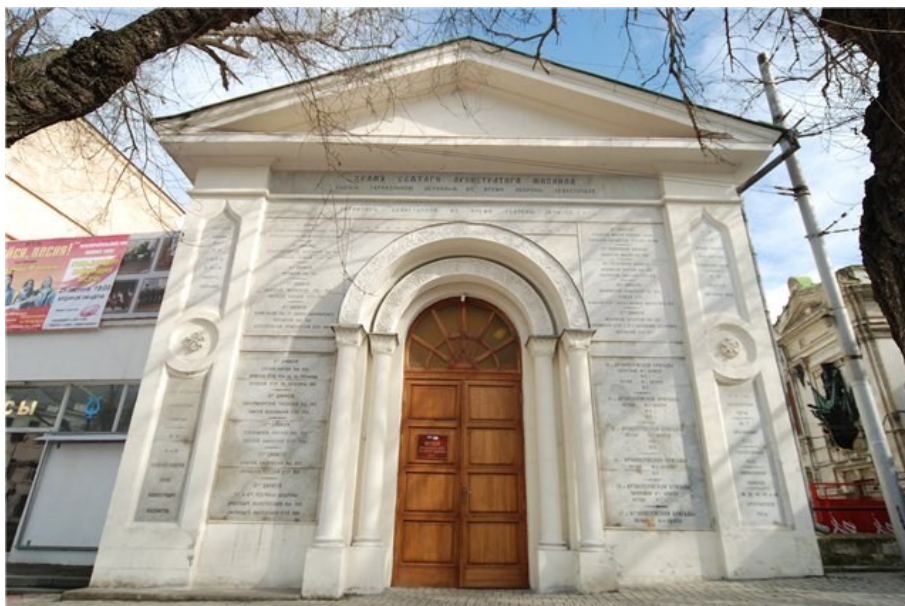
In the 1920s, in the building there was the Reading Room named after the French Communist Martyr. From 1931 Home Health Education was situated there. After World War II the building housed a small temple hall of the House of officers of the fleet. Since 1969 the hall number 8 of the Black Sea Fleet Museum is situated here (Fig. 2).

The building is rectangular in plan. Portal is in the form of niches in one another, covered by arches that rest on columns (two on each side) with Byzantine capitals. Archivolt is carved on the left and right of the entrance there are medallions with rosettes. The walls and columns are built up of small masonry blocks from Krymbalsk deposit (Inkerman).

Figure 2. Hall number 8 Black Sea Fleet Museum (Church of St. Michael the Archangel) in Sevastopol is directly adjacent to the House of officers of the Black Sea Fleet. 2012

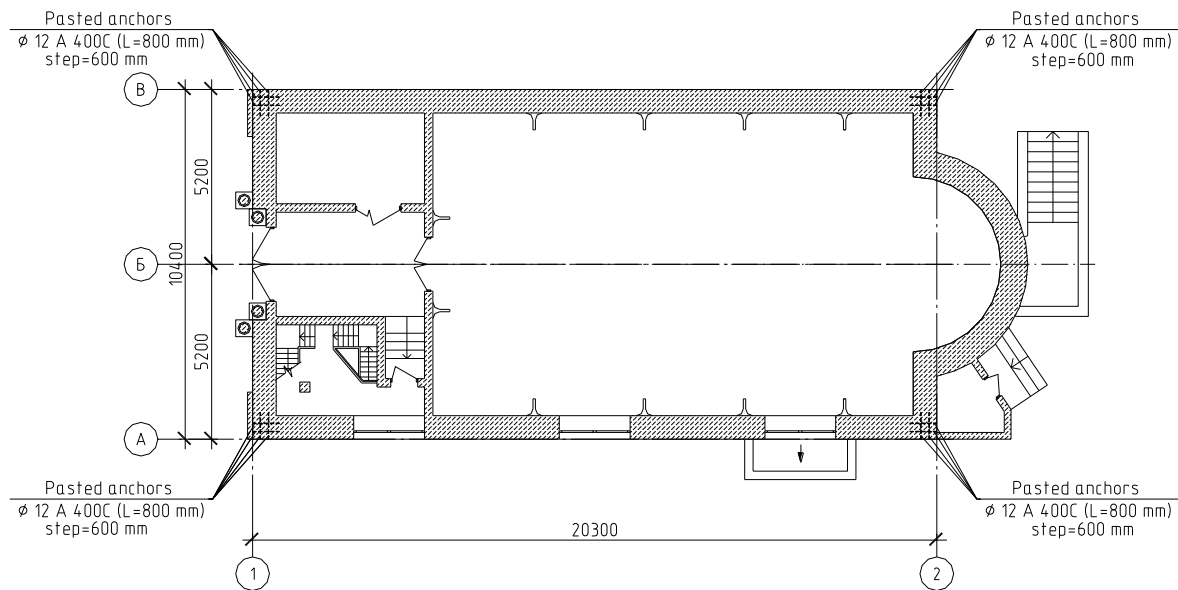
Figure 3. Scheme of strengthening the intersection exterior walls with help of pasted anchors of the Church St. Archangel Michael

In order to improve the building seismic resistance it is advisable to strengthen the outer corners of the building hidden by staging pasted anchors of reinforcing steel $\varnothing 12$ A 500 C length of 800 mm in mutually perpendicular directions. Be sure to mask their butts embedded indent by fragments of facade stone masonry (Fig. 3). Consolidation work arched bridges three windows of the southern wall (Fig. 4) by steel strip with pasted anchors (performed secretly unchanged appearance of the historic facade). Existing doorway in the south wall facade is converted into the window, according to the original appearance of the building.

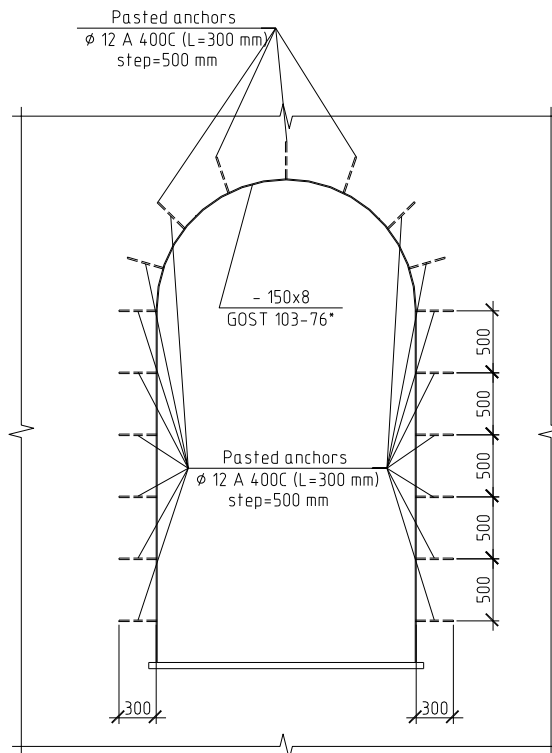
Figure 4. Amplification circuit arched window openings of the southern wall of the building by staging hidden pasted anchors

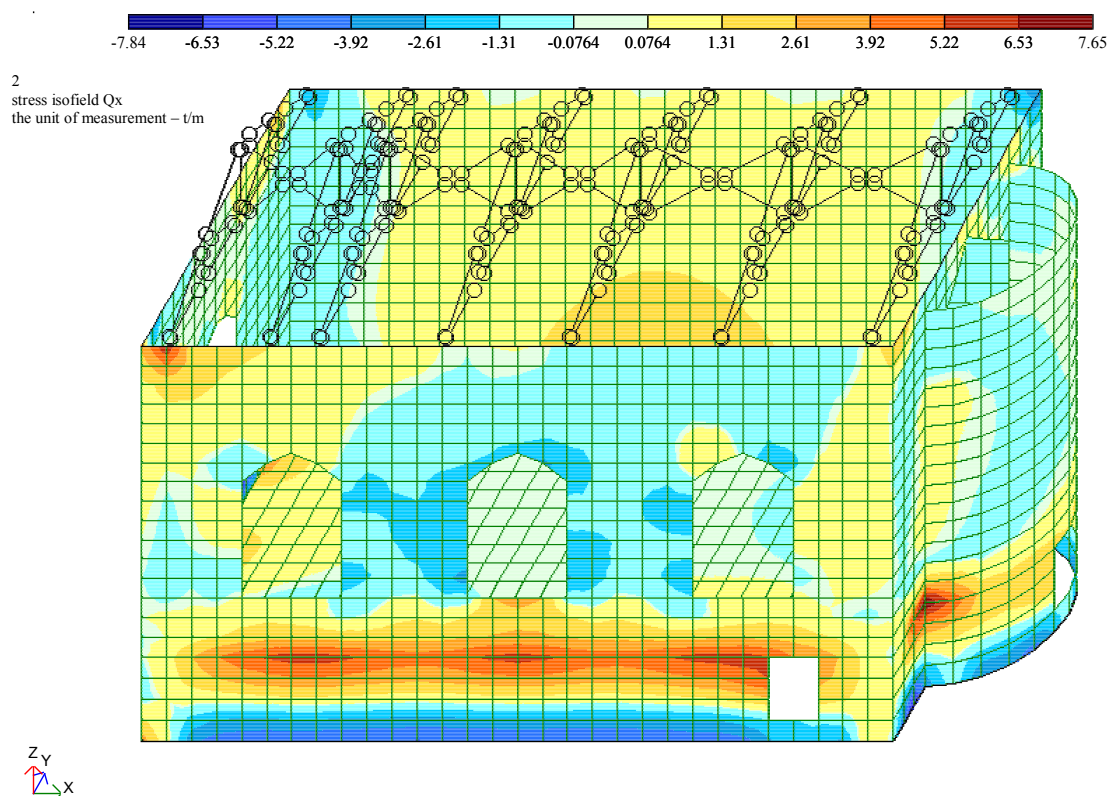
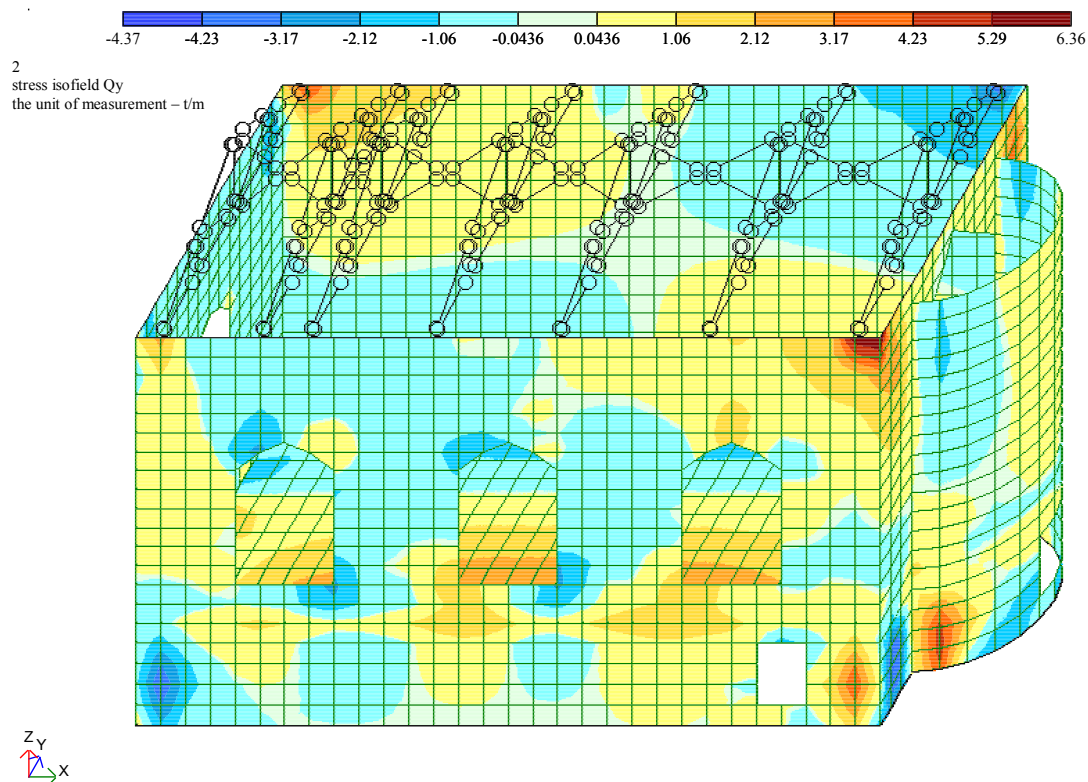
Figure 5. The contour plots of the critical types of stresses in the walls of the building

Spatial settlement building is made taking into account the recommended device of metal roof trusses connected by a common system with concrete belts on top of the walls (Fig. 5). Characteristics of materials adopted in accordance with the results of the survey. In the load on the farm is considered advisable to reconstruct the dome of a metal frame, the vertical part of which is trimmed with light facade materials.
