Impact behavior of rehabilitated post-tensioned slabs previously damaged by impact loading

A. Jahami^{a*}, Y. Tamsah^a, J. Khatib^b, O. Baalbaki^a, M. Darwiche^a, S. Chaaban^a

Jahami, A., Tamsah, Y., Khatib, J., Baalbaki, O., Darwiche, M., Chaaban, S. Impact behavior of rehabilitated post-tensioned slabs previously damaged by impact loading. Magazine of Civil Engineering. 2020. 93(1). Pp. 134–146. DOI: 10.18720/MCE.93.11

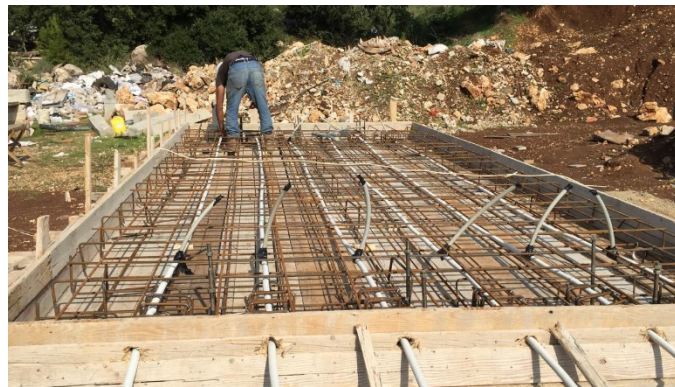
Figure 2. PT slab execution.

Two PT “post-tensioned” slabs are considered in this study each having a 660 cm×300 cm×25 cm dimensions. The slabs are prestressed with six equally distributed mono strands and reinforced with 10mm diameter bottom and top mesh at 250 mm spacing (Figures 1 and 2). The prestressing mono-strands have a draped profile and are grouted after casting the concrete to form a bonded system. Slabs’ dimensions and reinforcements considered the different gravity loads that act on a residential floor. The supporting system consisted of 10 cm diameter steel cylinders of 12 cm height resting on steel I-shaped beams, and the whole system is supported on two (60 cm×60 cm) concrete strip footings (Figure 3). As for the falling mass used to hit the slabs, a 605 Kg reinforced concrete block (60 cm×60 cm×60 cm) is cast inside an 8mm thickness steel mold to protect the concrete core from severe damage after impact; to be used for multiple drops (Figure 4).

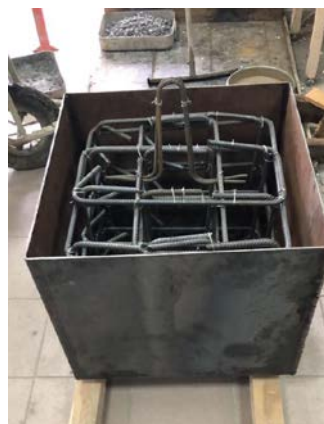
Figure 4. RC block reinforcement (cm).

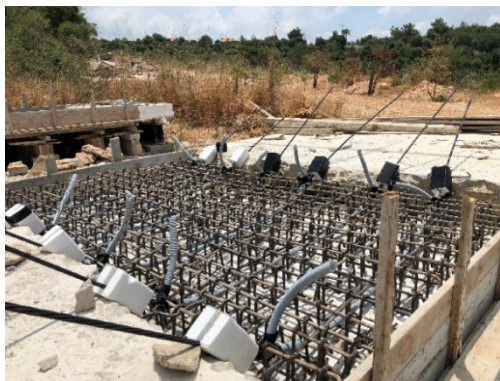
Figure 10. PT-1R slab before the concrete cast.

Once the damaged zone is removed, all severely damaged non-prestressed reinforcement were replaced with new ones. A set of 10 mm diameter cross ties (punching shear reinforcement) was prepared – (Figure 8) – and attached to both top and bottom flexural reinforcement at a spacing of 10cm to cover the whole zone. As for the prestressing steel, all ducts were removed so strands are working as non-prestressed steel; since no bond remains between strands and concrete. Hence, and to regain the prestressing behavior in this zone, new mono strands were installed beside the old ones (Figure 9). The original flexural strength for both slabs before the first impact was 107.5 KN.m, whereas, after rehabilitation, the flexural strength increased to 118.6 KN.m. In order to achieve a better connection between the old and new concrete, an inclination of 45 degrees was performed in the interface. This interface was roughened to increase the friction between old and new concrete. Figure 10 shows slab PT-1R after finishing rehabilitation procedure before casting.

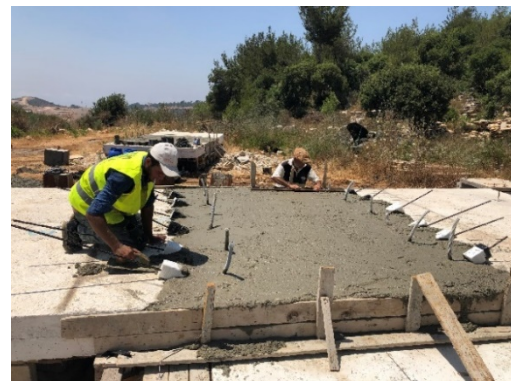
Figure 11. Concrete cast for PT-1R.

Finally, the new concrete was cast and cured with water for 2 weeks (Figure 11). Concrete mix strength was prepared to be the same as the old concrete cast for the first time. Three cylinders were tested at the impact test day and showed a compressive strength of 31 MPa. After casting, new sheets of neoprene pads were fixed at the impact zone as done previously, and accelerometers were placed at the same previous locations to have a valid comparison of the results with those of the original slabs before rehabilitation.

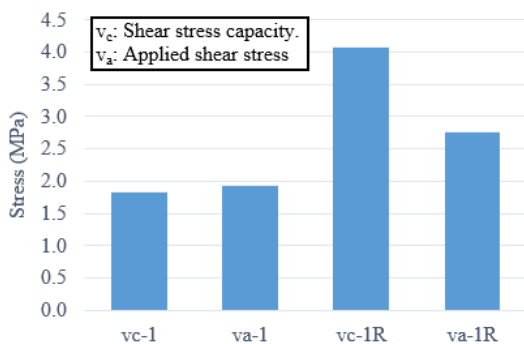
Figure 14. Shear stress for slabs PT-1 and PT-1R

Figure 14 shows the shear stress capacity and the applied shear stress for both slabs PT-1 and PT-1R. An increase of the punching shear capacity was observed from 1.83 MPa for slab PT-1 (before repair) to 4.08 MPa for slab PT-1R (after repair). This leads to a reduction in the shear demand ratio (v_n/v_{nc}) from 1.05 for slab PT-1 to 0.67 for slab PT-1R. As for slabs PT-2 and PT-2R, similar improvement was recorded where the shear capacity was increased from 1.83 MPa to 4.44 MPa respectively (Figure 15). This improvement was better for slab PT-2R than slab PT-1R; since the critical perimeter b for the edge drop case (PT-2R) is less than the critical perimeter for the center drop case (PT-1R), which led to a higher shear stress carried by crossties v_s in slab (PT-2R) than slab (PT-1R).

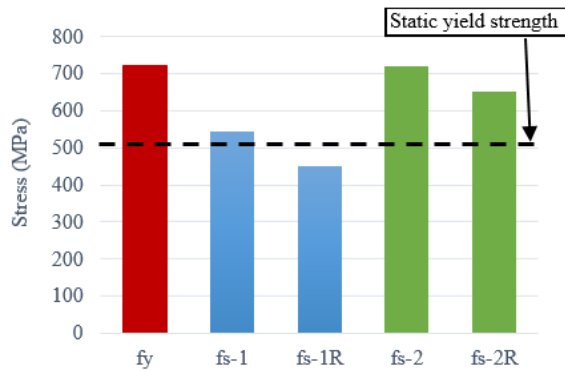
Figure 16. Rebar tensile stresses for slabs (PT-1, PT-1R, PT-2, and PT-2R)

Figure 16 plots the axial tensile stress at steel rebars f_s below the impact zone. It can be noted that the non-prestressed rebars at slabs PT-1 and PT-1R reached a tensile stress value of 542 MPa and 452 MPa respectively, which is around 75 % and 63 % of the dynamic yield stress (720 MPa) of reinforcing rebars. On the other hand, rebars in slab PT-2 were yielded as shown in Figure 16, whereas slab PT-2R recorded a rebar tensile stress of 653 MPa, which is around 91 % of the dynamic yield stress. This suggests that both repaired slabs (PT-1R and PT-2R) did not experience any yielding in steel rebars.

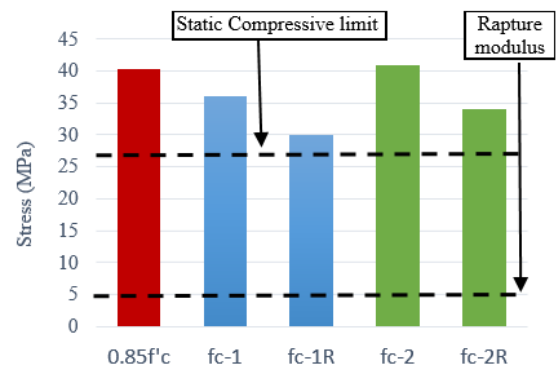
Figure 17. Top compression stresses for slabs (PT-1, PT-1R, PT-2, and PT-2R)

The second parameter was represented in Figure 17, where the compressive stresses in concrete f_c at the top fibre of the slabs are shown in the impact zone. As per ACI318-14 [21] requirements, the stress in compression should not exceed $0.85f'_c$ (i.e. 40 MPa) to avoid failure of concrete in compression. Results show that top compressive stresses for slabs PT-1 and PT-2 were 36 MPa and 41 MPa respectively, which means that slab PT-2 failed in compression. However, there was no compressive failure for both slabs after repairing, where the compressive stress was 30 MPa and 34 MPa for slabs PT-1R and PT-2R respectively. It was realized that for both top and bottom stresses slab PT-2R had higher values than slab PT-1R; because for slab PT-2R, the slab is hit at the mid-span of its free edge, which will lead to a higher top and bottom strain.

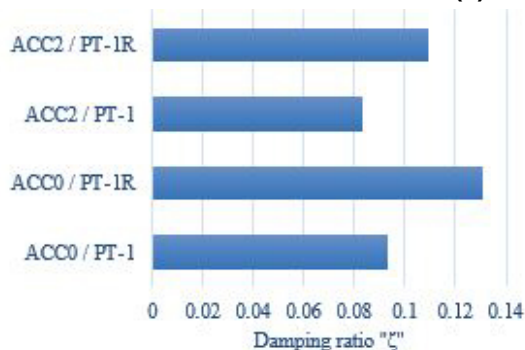
Figure 22. Damping ratio for slabs PT-1 and PT-1R
