Distribution of corrosion products at the steel-concrete interface of XD3 concrete samples

S.A. Abdulsada*, F. Kristaly, T.I. Torok

University of Miskolc, Miskolc, Hungary

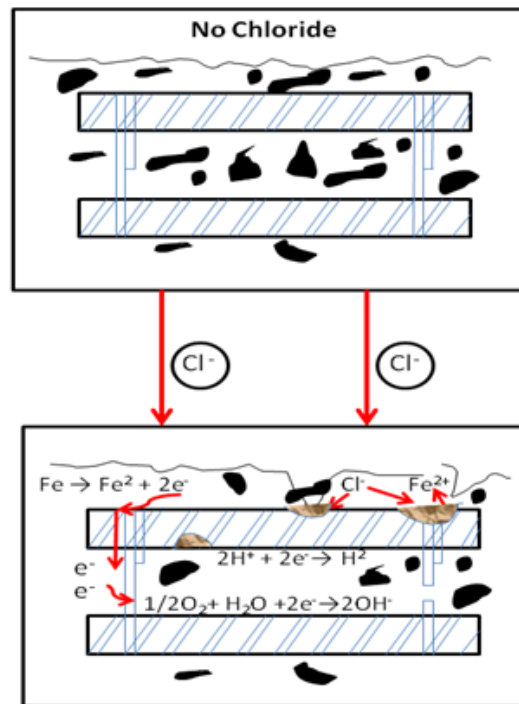
Figure 1. Electrochemical corrosion processes triggered by Cl⁻ ions reaching reinforcements, (modified from [11]).

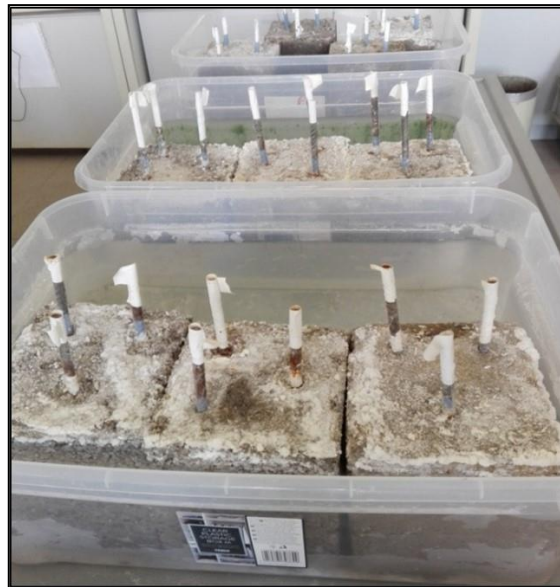
**Figure 2. Reinforced concrete samples were immersed in 3.5 % NaCl solution for 18 months.**

Mass percentages of the two special additives compared to the amount of cement type CEM II/A-S 42.5R for the prepared concrete samples are given in Table 1. The samples had been immersed and kept in 3.5 % NaCl solution for 18 months then the samples were removed from the 3.5 % NaCl solution as shown in Figs. 2, 3.

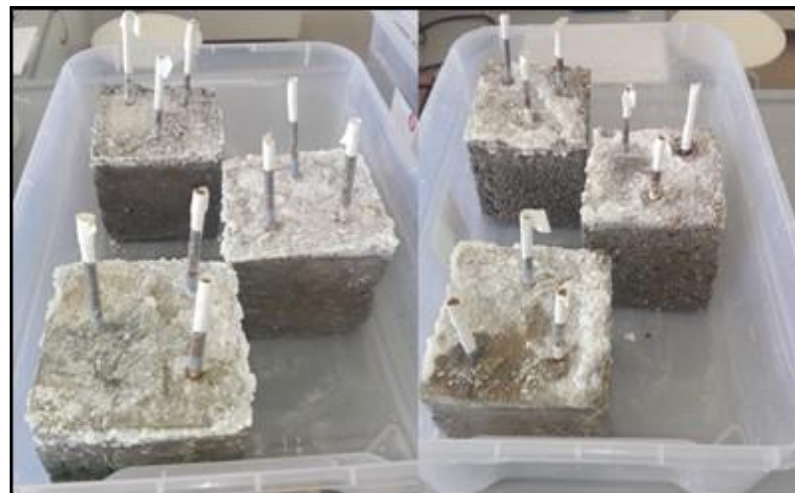
**Figure 3. Reinforced concrete samples removed after 18 months immersion in 3.5% NaCl solution.**

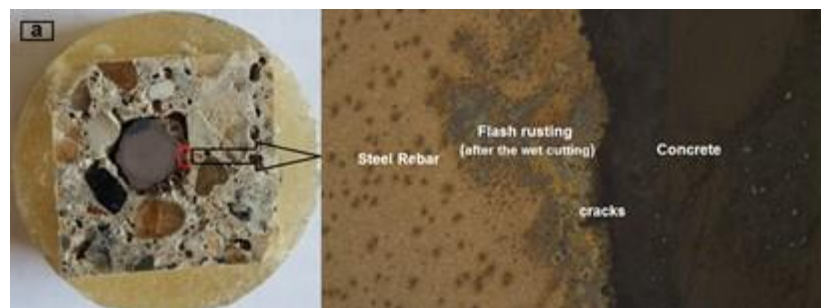
Figure 7. Light optical micrograph of the steel-concrete interface section with magnification 50X of the sample: a) A1, b) B1, c) C1, d) A2, e) B2, f) C2, showing the microstructure and the corrosion attack.

Light optical micrograph for all concrete samples is presented in Fig. 7.

The visual examination revealed that in 75 % of all cases, corrosion initiated between the rebar ribs or directly at the rib edge as shown in Fig. 7a,d (samples A1 A2) and the type of corrosion as a flash rusting (after wet cutting for samples), also the cracks and air void appeared in these samples.

Fig. 7b (sample B1) illustrates there's a steel manufacturing (rolling) defect (void) and small a flash rusting (after wet cutting for samples) areas.

Inspection of the steel-concrete interface upon corrosion initiation typically revealed the presence of one distinct corroding spot, which in some cases was surrounded by significantly smaller corrosion pits, all of them within an area of maximum approximately 1 mm² as shown in Fig. 7e (samples B2). The small corrosion pits were interpreted as sites where corrosion had initiated but was not able to reach stable pit growth (in contrast to the dominating corrosion site), these pits were typically covered with a crust of corrosion products, which occasionally remained even after the chemical cleaning process in inhibited hydrochloric acid.

Inspection of the samples C1 and C2 (Fig. 7c,f) showed there is no pits corrosion or cracks at the steel-concrete interface.
