## Behavior of heat damaged reinforced recycled aggregate concrete beams repaired with NSM-CFRP strips

**Abstract.** The behavior of heat damaged Recycled Aggregate Concrete (RAC) beams repaired with NSM-CFRP strips is the subject of this experimental study. The effect of heat damage on the RAC beams and the post-heating residual strength of beams were studied and compared with natural beams. Different volumetric percentages (0 %, 25 % and 50 %) of coarse Recycled Concrete Aggregates (RCA) were used in three concrete mixes (N, R25 and R50), producing a total of 16 reinforced beams having the same cross-section (100 mm×150 mm×1150 mm). Specimens were exposed to two levels of heat, 25 °C at ambient air and 400 °C for a three-hour period. The post-heating residual strength of RAC beams was studied and compared with natural ones. The flexural test conducted indicated a reduction in the load carrying capacities and stiffness due to mechanical deterioration in concrete properties and bond strength. The reduction in stiffness increased as RCA content increased due to a large amount of weak decomposed cement mortar in the RAC. The NSM-CFRP strips technique was used with epoxy adhesive for

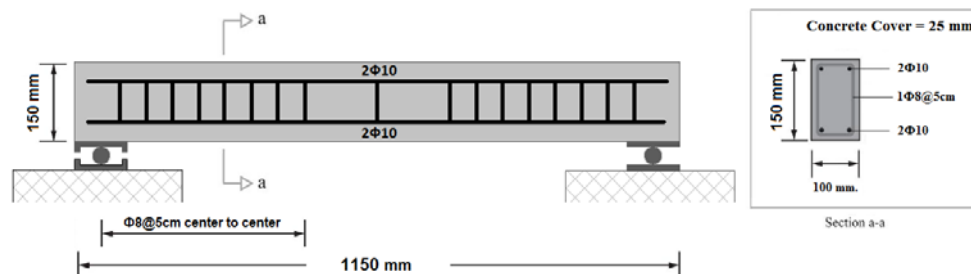
**Figure 1. Specimens and beam fabrication.**

The study program involved sixteen reinforced concrete beams (100×150×1150 mm) designed to be under-reinforced by following the guidelines of the ACI committee 318 [47]. All beams were provided with typical longitudinal and transverse steel reinforcements. The bottom (tension) reinforcement consists of two  $\Phi 10$  bars, the same as the top (compression), running along the full span of the beam. Also, the transverse shear reinforcement was roughly designed according to the ACI committee 318 [47] taking into account both the additional rise in ultimate load capacity due to the application of NSM-CFRP strips and the low shear resistance of the heat-damaged recycled aggregate concrete beams. The shear reinforcement consisted of closed 8 mm undeformed steel stirrups, distributed along the shear span and spaced 50 mm centers apart. The steel reinforcements were provided with concrete cover spacers (25 mm) at the bottoms and sides to ensure sufficient cover, then placed in the wooden formworks, as shown in Fig. 1. Specimens were divided into three main groups based on the concrete mix cast. Each group of specimens was cast with a specific concrete mix (N: natural aggregate, R25: 25 % recycled aggregate and R50: 50 % recycled aggregate) and moist-cured for 28 days. Each group was also subdivided into three sets in terms of the level of temperature exposure (25 °C at ambient air, and 400 °C).

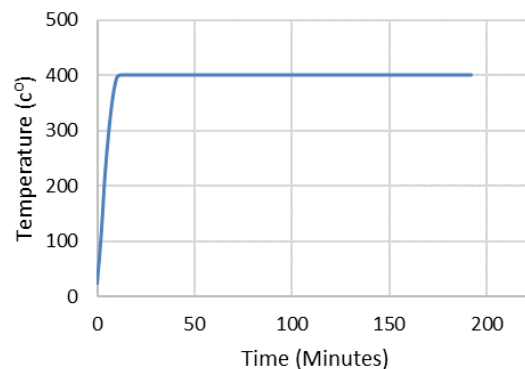
**Figure 2. Temperature history of heated specimens.**

Concrete specimens (beams and cylinders) were subjected to elevated temperatures using the electrical furnace available at the structural laboratory. The specimens were exposed to 400 °C (T400) heat for 3 hrs. The rate of heating is shown in Fig. 2.

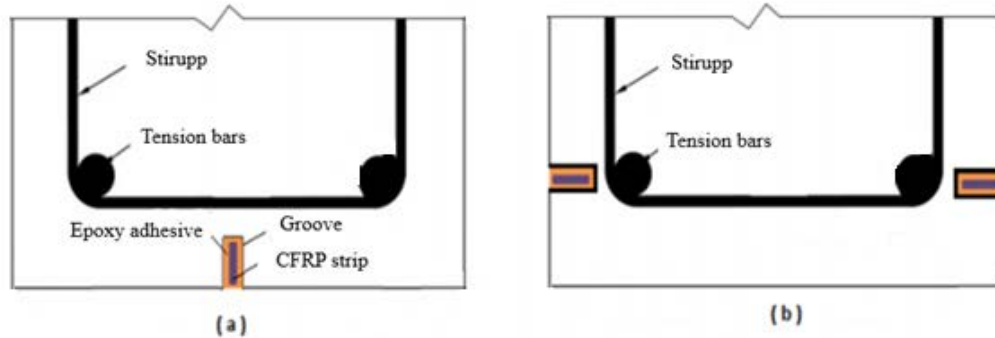
**Figure 3. A schematic drawing of the repairing configurations: (a) Single concentrated strip at soffit (S1), (b) Two strips at sides, one strip at each side (S2).**

Finally, each set contained an unrepaired beam used as a control specimen, designated with the symbol (C), and a repaired or strengthened beam using NSM-CFRP strips. Two configurations were used for strengthening/repairing: single strip centered at the bottom or double strip at sides (one strip at each side). Each configuration was designated with the symbol S1: One strip at bottom, or S2: Two strips at both sides, respectively. Fig. 3 (a and b) shows a schematic drawing of the repairing configurations. Table 7 illustrates the characteristics of different specimens.

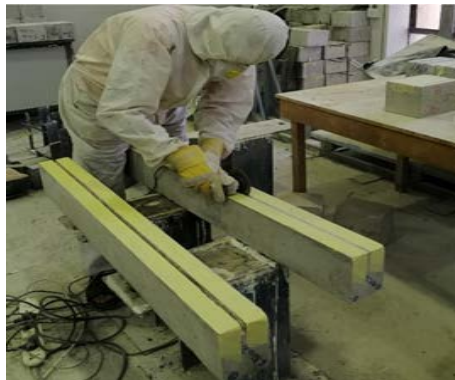
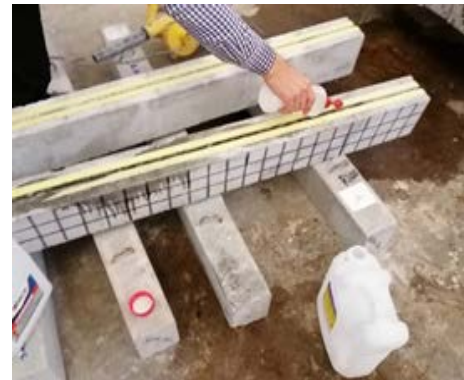
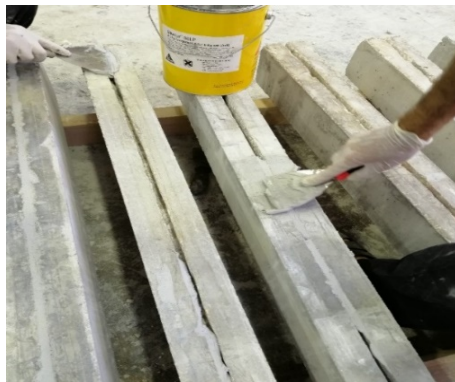
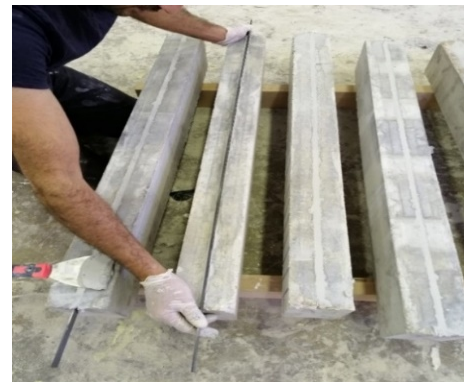
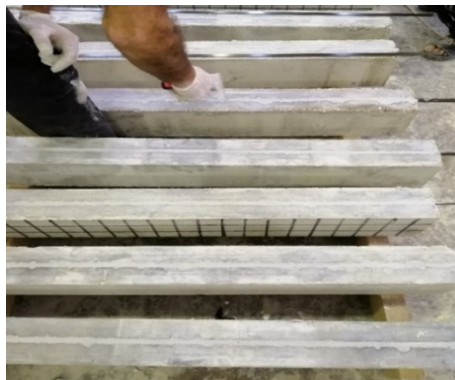
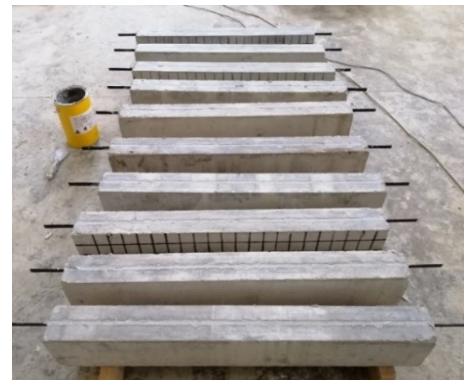
**Figure 4. NSM CFRP strips installation.**

(b) Groove cleaning with thinner

(c) Filling the grooves with "epoxy" paste

(d) Installation of CFRP strips in groove

(e) Finishing the surface

(f) Strengthened/Repaired beams

For installing the NSM CFRP strips, 25 mm depth and 8 mm width slits were cut using an electric drill for the considered configurations. Slit geometry was considered in this study to fit the dimensions of the CFRP strip employed. The slits were cleaned by an electric air blower before washed with a volatile liquid (thinner) to remove the suspended dust and reduce surface humidity. Later, the bonding adhesive was manually squeezed into the slits filling them completely using a special spatula, then the NSM CFRP strips were pressed into the epoxy up to the full depth of the slits, with the excess epoxy used to finish the surfaces covering the strips. Fig. 4 shows the NSM-CFRP strips installation process.

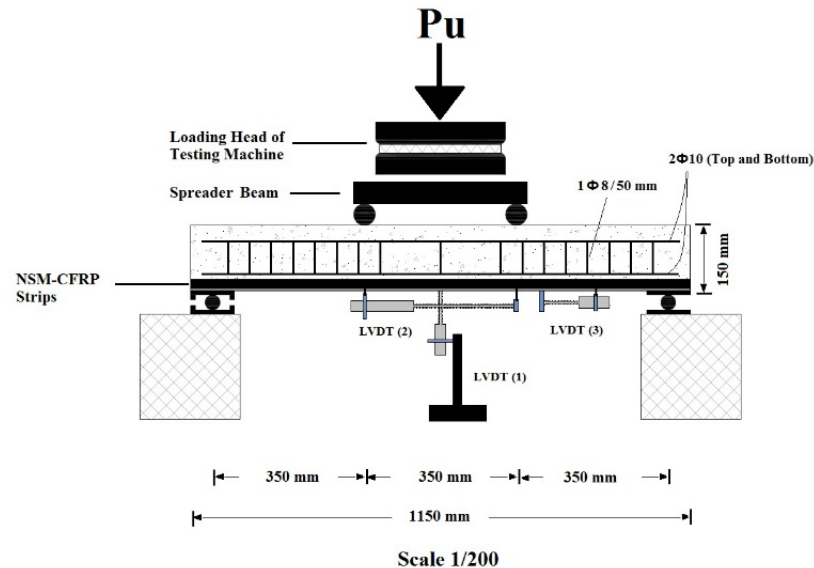
Figure 5. A schematic drawing of the test setup and LVDT's distribution.

All beam specimens were simply supported (one end is a hinge and the other is a roller) over a span of 1.05 m on-center, then subjected to four-point loading applied through a spreader beam. The distance between two point-loads was fixed at 350 mm. Three linear variable displacement transducers (LVDT's) were used. The first one was placed beneath the beam at the mid-span center to measure deflection,

whereas the second one was positioned horizontally to measure the longitudinal strain developed in CFRP strips. The latter was mounted on two short extensions of CFRP strips glued to the main NSM CFRP strips at two points over a gauge length of 350 mm around the center of the beams. Similarly, the third LVDT recorded the end slippage 150 mm apart from the center of support attached to a small piece of CFRP strip glued to the NSM CFRP strip in a pre-cut groove in which the head of the LVDT hits the center of small plastic plate glued to concrete surface. A schematic drawing of test setup is presented in Fig. 5.

The load was automatically applied using a universal testing machine of 2000 KN capacity with displacement controlled at 0.041 mm/s loading rate. Using a data acquisition system, instantaneous measurements of load, mid span deflection, elongation in NSM CFRP strip, and relative slippage between the concrete and the bonded CFRP strip were automatically recorded too.

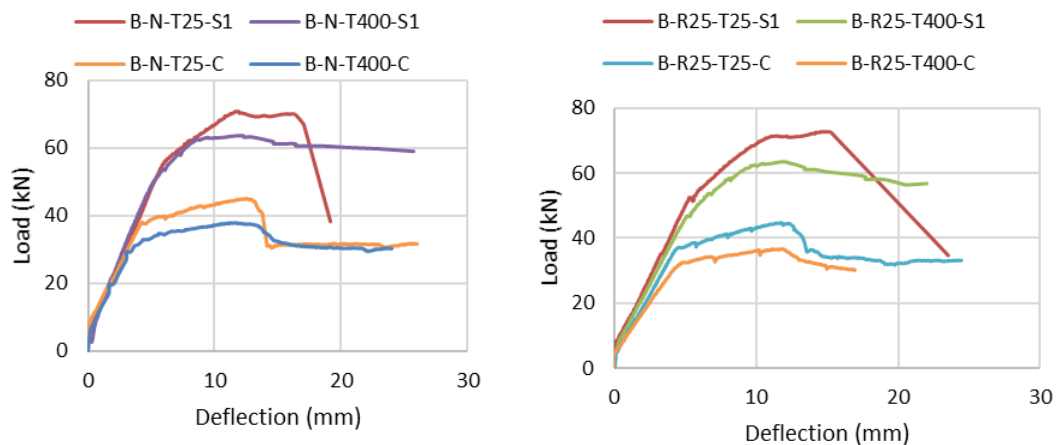
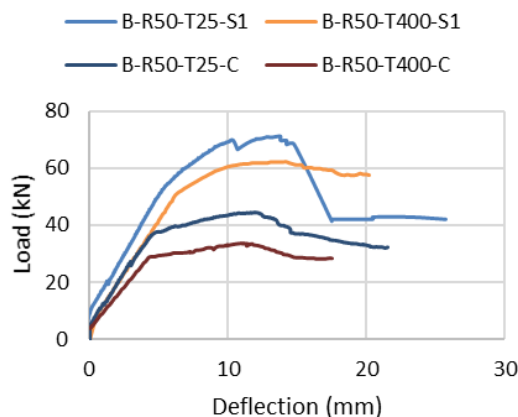
Figure 6. Effect of using NSM-CFRP strips at different levels of heat exposure.

(a) Normal concrete strips

(b) R25 concrete beams

(c) R50 concrete beams

The load–deflection curves presented in Fig. 6, 7 and 8 can be divided into three stages: elastic stage (pre-cracking), post-cracking stage, and yield strengthening stage. In the elastic stage, the specimen's flexural stiffness is given by the uncracked section, resulting in a linear load versus displacement curve. As the load was increased above the  $P_{cr}$ , micro-cracks developed in the specimen, with noticeable cracks appearing in the weak zone of the constant bending moment region. Meanwhile, the slope of the load–displacement curve is decreasing, as can be seen in Table 9, meaning that the beam's bending stiffness is decreasing, indicating that the beam is entering the crack production stage. When the load reaches the yield load, the specimen enters the yield strengthening stage. The load increased slowly at this stage, with a large increase in displacement.

According to Table 8 and Fig. 6, the load-deflection curves of specimens (B-N-T400-C, B-R25-T400-C and B-R50-T400-C) showed similar trend behavior. Curves were approximately linear up to certain point before they became non-linear. The deterioration in the mechanical properties is due to the decrease in the value of yield stress for steel and deterioration of bond strength between reinforcing steel and concrete, in addition to the large decrease in the post-heating compressive strength of concrete caused by concrete degradation and thermal cracks. The stiffness of the intact concrete beams was slightly affected by the recycled concrete aggregate content, but for the heat-damaged beams, the recycled concrete aggregate content had a significant effect on the stiffness due to the weaker bond between the damaged recycled aggregate concrete and the reinforcing steel. For beams exposed to an elevated temperature of (400 °C) for three hours, results showed that a significant difference between mixes and the reduction in load capacity was relatively low due to the fact that the strength was controlled by the compressive strength of heat-damaged concrete and the yielding of the steel reinforcement. The last is not significantly affected by temperatures below 700 °C.

Fundamentally, the use of NSM CFRP strips for strengthening and repairing shows a significant enhancement in the beams' behavior including increasing the load carrying capacity as shown in Table 8 and Fig. 6. Strengthened specimens showed a similar and typical mechanical response. For example, the load carrying capacity of specimens B-N-T25-S1 and B-R50-T25-S1 were 61 % and 60 % higher than B-N-T25-C and B-R50-T25-C controlled specimens, respectively. The load-deflection curves were divided into three stages. In the first stage (elastic stage), the load increased linearly up to certain values of load and deflection, causing the initiation of the first crack in the concrete. In this stage, the bond between the CFRP strips, epoxy material, and concrete was good. In the second stage (concrete cracking to steel yielding), the curve changed its slope due to the weaker modulus of CFRP strips and steel yielding, reflecting the linear elastic response of the cracked composite section started by concrete cracking to steel yielding due to increasing bending moment. Finally, the third stage (steel yielding to failure), reflects the nonlinear behavior of the composite section.

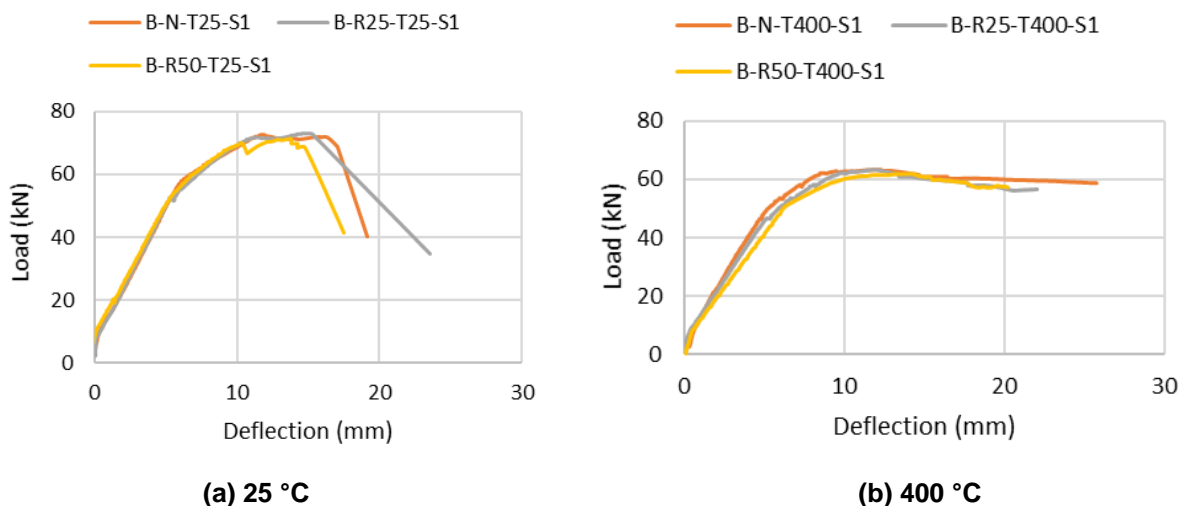
Figure 7. Effect of RAC percentage on the load-deflection response.

Results showed typical behavior of beams with different percentages of recycled concrete aggregate as shown in Table 8 and Fig. 7. This is due to the strength of concrete, since all concrete mixes have the same strength regardless the recycled aggregate content indicating that Recycled Concrete Aggregate does not have an effect on the load capacity when the strength of concrete is fixed, but the deflection slightly increases as RCA increases because of the low modulus of elasticity of RAC. From Table 8, the load carrying capacity of specimens B-N-T25-C, B-R25-T25-C, and B-R50-T25-C having different RA content is almost the same.

For heat-damaged specimens at 400 °C, due to the lower tensile strength of RAC and the deterioration in mechanical properties of concrete associated with the heat-damage due to elevated temperatures, the repaired specimens exhibited comparable residual load-carrying capacities but noticeable difference for deflection as the recycled aggregate increased. On the other hand, the stiffness showed a reduction as recycled aggregate increased. For example, from Table 9, the post cracking stiffness of specimens B-N-T400-C, B-R25-T400-C, and B-R50-T400-C were 6.6 kN/mm, 6.3 kN/mm and 5.9 kN/mm, respectively.

This can be related to the significant decrease in bond strength between the damaged concrete and the epoxy adhesive as the recycled aggregate content increases. Heat-damaged recycled aggregate concrete with a high incorporation ratio of recycled concrete aggregate contains a larger amount of damaged mortar surrounding the epoxy leading to a weaker bond as shown in Fig. 7.

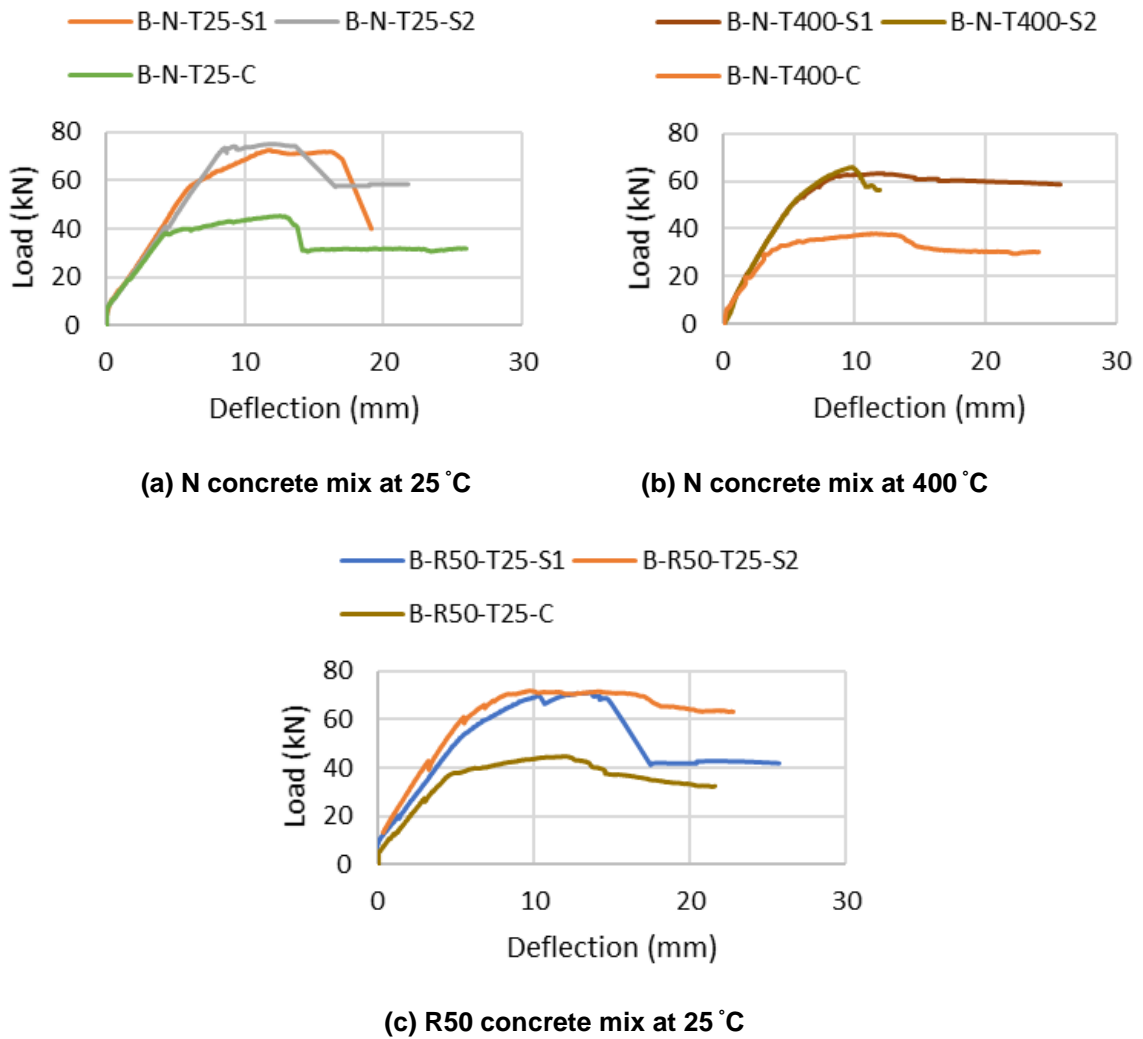
Figure 8. Effect of NSM-CFRP strips strengthening/repairing configuration.

In this part, the differences between strengthening/repairing configurations are discussed. Fig. 8 shows load-deflection curves of BNSM-CFRP (S1) and SNSM-CFRP (S2) for different percentages of recycled aggregate content and different levels of heat exposure. Table 8 summarizes the other parameters including stiffness and modulus. Generally, specimens strengthened/repared with SNSM-CFRP strips (one strip at each side) showed a significant increase in the cracking load due to a higher ratio of CFRP strips. The load carrying capacity shows a slight change, however, the stiffness significantly increased but toughness decreased. In comparison with the first configuration, the second configuration indicated a significant increase in cracking load and stiffness but a significant reduction in deflection and toughness. Moreover, the ultimate load capacity does not affect the configurations.

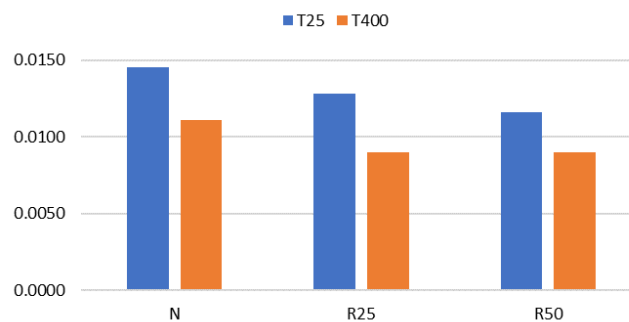
Figure 9. Strain induced in NSM CFRP strips to ultimate vs. temperature for heat-damaged/ repaired and unheated/ strengthened beams.

Fig. 9 shows that the induced strain in NSM-CFRP strips is significantly affected by the recycled concrete aggregate; the strain decreases when the RCA percentage increases due to a drop in the bond between CFRP strips and the surrounding concrete. The bond between the NSM-CFRP strips and the concrete cast with natural aggregate is stronger than the bond between the NSM-CFRP strips and the RAC. The reason for the reduction in bond strength is the recycled concrete aggregates consist mostly of cement mortar attached to old virgin aggregate. The mortar itself has lower strength than the virgin aggregate. Using SNSM CFRP in strengthening/repairing specimens significantly reduced the induced strain in NSM-CFRP strips because a larger resisting area available to handle the stresses developed. Fig. 10 shows a comparison between NSM CFRP and SNSM CFRP in terms of strain induced in the CFRP strips.

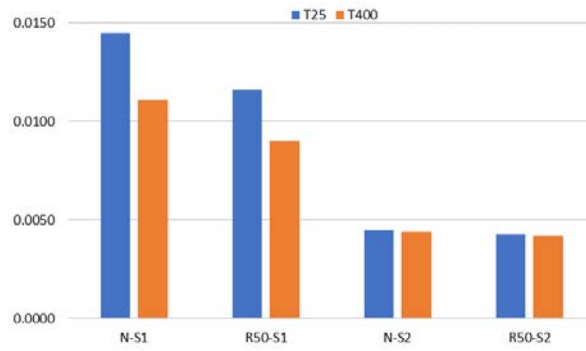
**Figure 10. Strain induced to ultimate vs. temperature for different strengthening/ repairing configurations.**

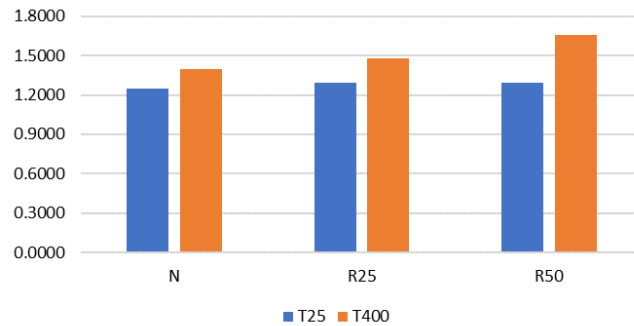
**Figure 11. Bond slippage between NSM CFRP strips vs. temperature for heat-damaged/repaired and unheated/strengthened beams.**

Fig. 11 shows that the bond slippage occurred between CFRP strip and surrounding concrete substrates in the first configuration with one strip at the bottom. The slippage is significantly affected by the recycled concrete aggregate. The maximum slippage at ultimate load increases as the RCA content increases due to lower bond strength between CFRP strips and the surrounding concrete because of the large amount of cement mortar attached to the aggregate in RCA. Fig. 12 indicated that using two strips at the sides helps to minimize the slippage to about 40 % of its value in the first configuration (S1) where a single concentrated strip at the bottom is used.

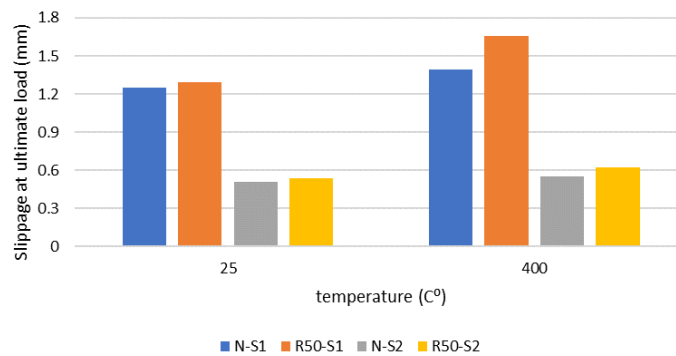
**Figure 12. Bond slippage at ultimate load vs. temperature for different strengthening/ repairing configurations.**

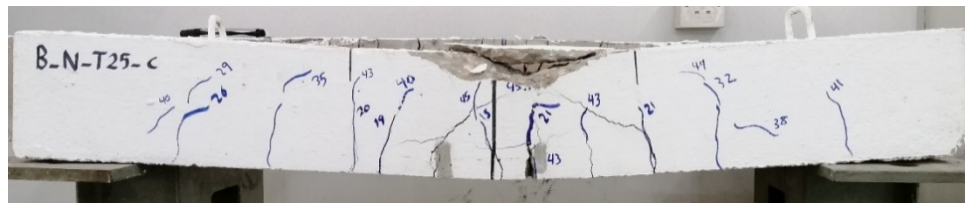
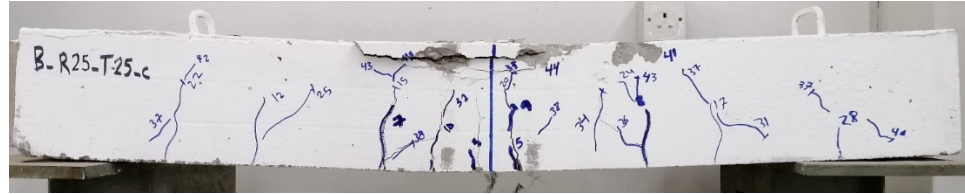
Figure 13. Failure mode of unheated control specimens at 25 °C.

a) B-N-T25-C, Loading cracks

b) B-R25-T25-C, Loading cracks

Fig. 13 and Fig. 14 show unheated and heat-damaged control beams at failure. All specimens exhibited a flexural mode of failure. Unheated beams, subjected to four-point loading, showed a typical crack propagation as shown in the pictures of Fig. 13. Cracks initiated within the middle of the span at the tension side when the tensile capacity of concrete was reached. By adding further loads, shear cracks appeared diagonally near the supports in the high shear zones and more flexural cracks became visible and extended to the compression side until failure load. Generally, for the same grade of concrete, the recycled aggregate content did not affect the cracks pattern but reduced the load at which the cracks appeared as the recycled aggregate content increased because the RAC has lower mechanical properties.

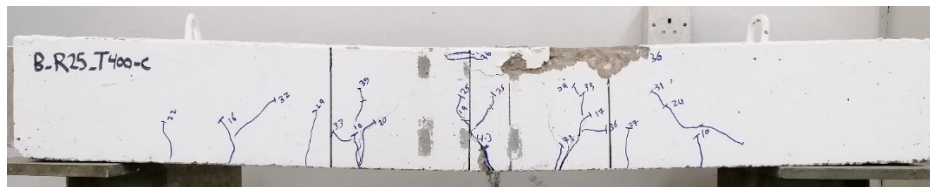
Figure 14. Failure mode of control test specimens heated at 400°C for 3 hrs.

b) B-R25-T400-C, Loading cracks

For beams damaged at 400°C, Fig. 14 indicated that failure mode and cracking patterns are similar to those of unheated beams, Cracks initiated at straight vertical profiles in the middle of span in the tension zone before diagonal cracks appeared near the supports. Then more cracks appeared and extended to the compression side, leading to failure. Specimens failed by yielding of tensile steel and then compression failure in concrete at the compression zone with an increase in the number of cracks.

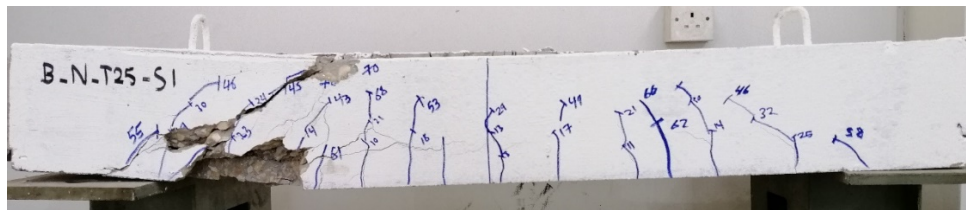
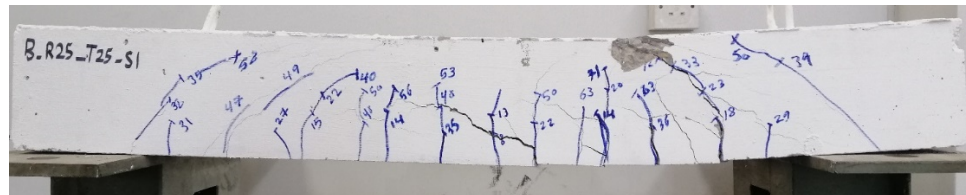
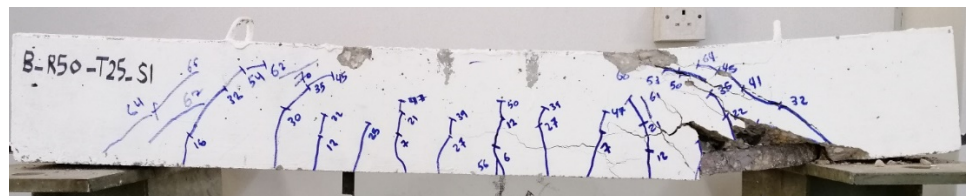
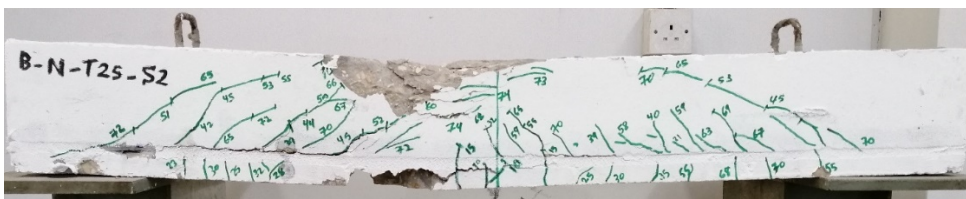
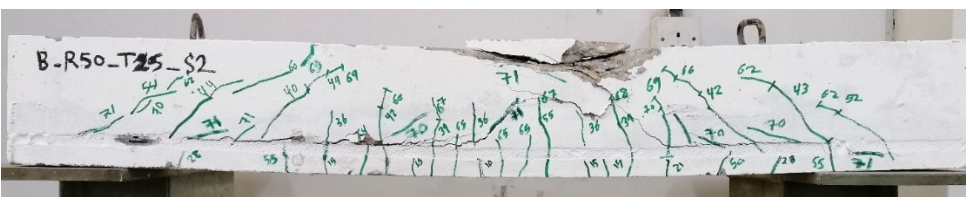
**Figure 15. Failure mode of strengthened specimens at 25 °C.**

a) B-N-T25-S1, Loading cracks

b) B-R25-T25-S1, Loading cracks

c) B-R50-T25-S1, Loading cracks

d) B-N-T25-S2, Loading cracks

e) B-R50-T25-S2, Loading cracks

The failure modes of intact specimens strengthened with one NSM-CFRP strip at the bottom are shown in Fig. 15. For specimens B-N-T25-S1, B-R25-T25-S1, B-R50-T25-S1, and B-R100-T25-S1, when the load applied, flexural cracks initiated at the middle zone, and with further application of the load, diagonal cracks initiated near supports in the high shear zone with inclination before the cracks propagated rapidly toward the high-stress zone. Near ultimate load, horizontal cracks at the web appeared and caused a cover separation. The collapse of the beams started with partial concrete cover separation followed by

shear failure. On the other hand, specimens strengthened with SNSM CFRP Strips (two strips, one strip at each side), B-N-T25-S2 and B-R50-T25-S2, at ultimate stage, failed by the horizontal cracks that appeared and caused cover separation and then flexural failure followed by concrete crushing. The collapse of the beams started with partial concrete cover separation followed by concrete crushing.

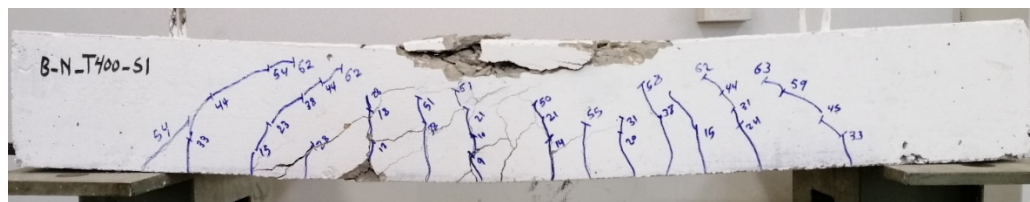
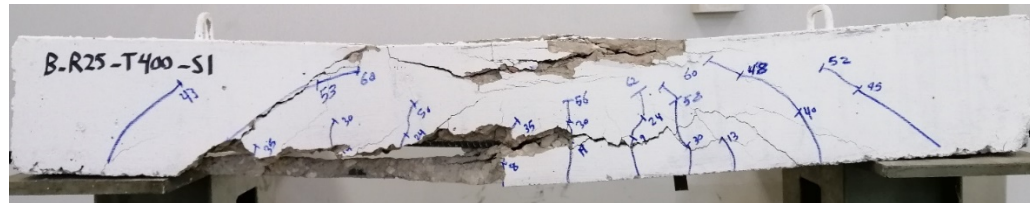
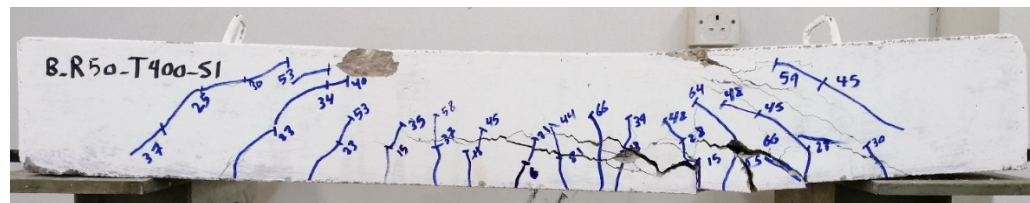
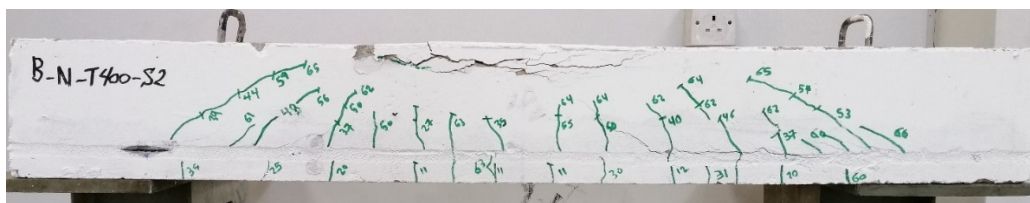
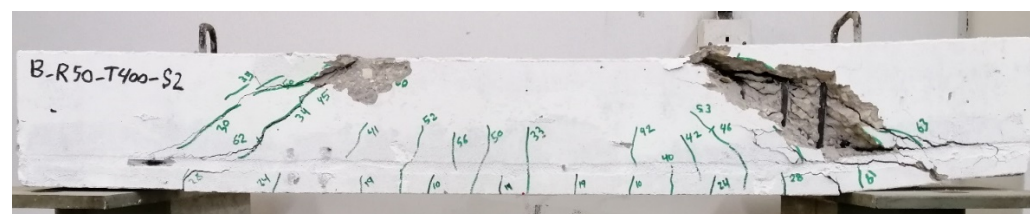
**Figure 16. Failure mode of repaired test specimens after heating at 400°C for 3 hrs.**

a) B-N-T400-S1, Loading cracks

b) B-R25-T400-S1, Loading cracks

c) B-R50-T400-S1, Loading cracks

d) B-N-T400-S2, Loading cracks

e) B-R50-T400-S2, Loading cracks

Specimens that heat-damaged at 400 °C and were repaired with one NSM CFRP strip at the bottom are shown in Fig. 16. For specimens B-N-T400-S1, B-R25-T400-S1, B-R50-T400-S1, and B-R100-T400-S1, when the load applied, flexural cracks were initiated at the middle zone, and with further application of the load, diagonal cracks initiated near supports in the high shear zone with inclination before they propagated rapidly toward the high-stress zone. However, near ultimate load, specimens with different concrete mixes showed different failure modes.

For B-N-T400-S1, partial cover separation with hair-line cracks in the concrete at the compression zone appeared due to concrete crushing. Local splitting of the epoxy cover was noticed. Specimen B-R25-T400-S1 experienced concrete crushing at the same time with partial concrete cover separation. In contrast, B-R50-T400-S1 failed by horizontal cracks that caused partial cover separation followed by shear failure, whereas B-R100-T400-S1 failed by shear. This is because shear capacity is more dependent on concrete than steel in addition to the low shear resistance of RAC as RCA% increases. On the other hand, specimen B-N-T400-S2, repaired with SNSM CFRP Strips (two strips, one strip at each side), failed at the ultimate stage by concrete crushing, whereas B-R50-T400-S2 experienced partial cover separation followed by shear failure. This is because recycled aggregate concrete has a reduction in concrete's mechanical properties including compressive strength and tensile strength in addition to the lower shear resistance of beams cast with RAC.
