Research article

## The GPR survey method in combination with destructive testing methods for the hydraulic structures technical condition studying

**Abstract.** The study examined the technical condition of hydraulic structures (HS) to plan their reconstruction, restoration and development of protective measures. The Sarpinskaya Watering and Irrigation System (SWIS) in the Republic of Kalmykia was the object of study. Promising research and monitoring methods were used: testing of concrete core samples using universal testing machine MIM.4-1000 and ground penetrating radar probing (by the GPR OKO-3) with ground penetrating radar survey of HS. Based on the results obtained, it can be concluded that concrete and reinforced concrete structures on the territory of the SWIS (namely, pumping station No. 1) have low strength, which is explained by their long service life and the lack of major repairs. The studied core samples collapsed under a minimum load of 116...118 kN. This indicates severe wear of the concrete coating of HS, aggravated by the close occurrence of groundwater. Further destruction of the concrete coating is inevitable, and therefore urgent repair and reinforcement of

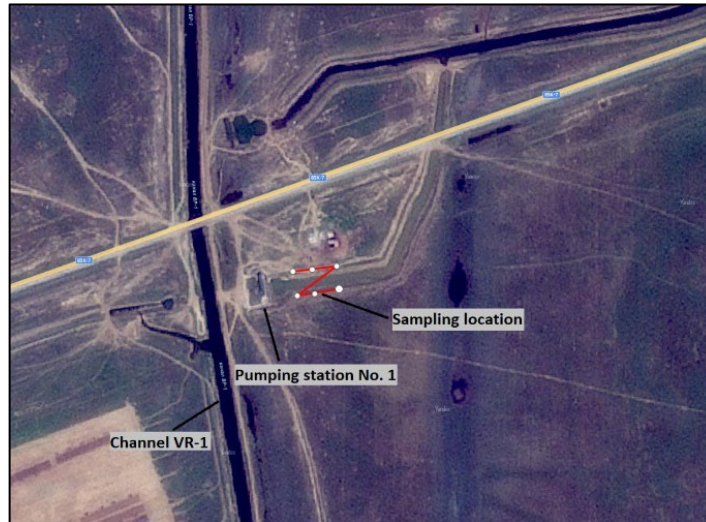
In 2023, georadolocation survey was carried out at certain SWIS sites in the Oktyabrsky District of the Republic of Kalmykia using the GPR OKO-3. Concrete samples were taken from some sections of the concrete lining of the drainage channel for further study in the laboratory (Fig. 1).

**Figure 1. Places of concrete cores sampling.**

The cores were taken from the area of pumping station No. 1 of the SWIS. The sampling site was chosen taking into account the minimum possible damage to HS, at a distance of 600 mm from the joints and edges of the coating, in the area free from reinforcement. The number and location of drilling spots are determined by local conditions.

The GPR survey was performed at the place where the core samples were taken (Fig. 1). The GPR survey of HS was carried out using the GPR OKO-3, manufactured by JSC Geotech (Russia), equipped with a 2-frequency antenna unit 150+400 MHz (Fig. 5).

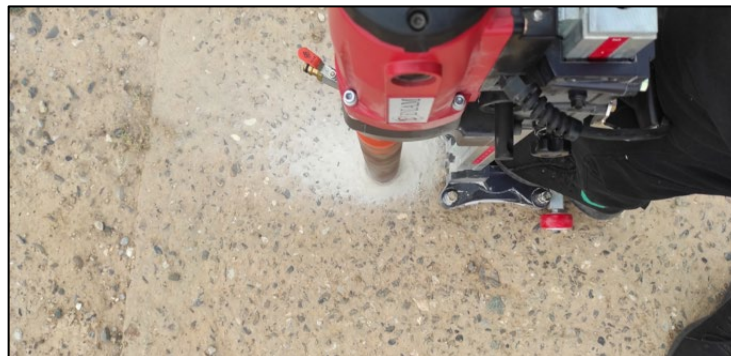
To obtain complete and accurate information about the HS condition, a destructive testing method, “Core sampling and testing” was used, which was carried out on selected sections of HS with the use of a diamond drilling rig (Fig. 2).

**Figure 2. Process of cutting the cores using a diamond drilling rig.**

However, after the core was extracted, such a structural characteristic as load-bearing capacity of the structure under study may change. Therefore, it is recommended to extract a concrete sample only with the marks made in advance by the developer, so that the loss of a part of the structure would not affect its strength characteristics in any way. The place, from which the core was removed, was filled with concrete and the surface was leveled.

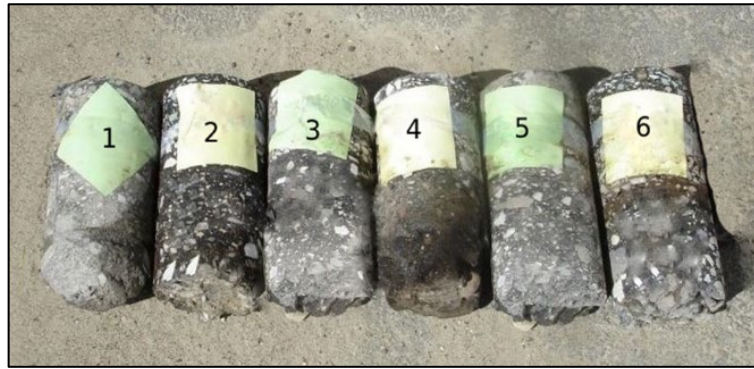
After cutting, the concrete core samples were sent to the laboratory to determine their strength by measuring the minimum force required for destruction. The number of samples in the series was 6 pieces (Fig. 3).

**Figure 3. Concrete samples from the SWIS.**

From Table 1, it can be seen that samples No. 3, 4, 5, 6 were destroyed at a minimum load of 116...118 kN. These data indicate a strong wear of the concrete coating of HS, which is complicated by the close occurrence of groundwater, which will cause further damage to the coating.

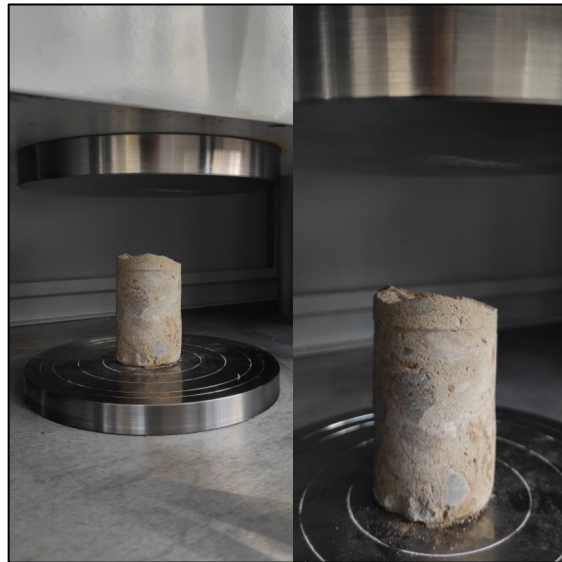
Compression tests of samples were carried out in the laboratory of the Federal Scientific Centre of Agroecology, Complex Melioration and Protective Afforestation of the Russian Academy of Sciences on universal testing machine MIM.4-1000 (Fig. 4). The laboratory analysis consisted of a static load with its constant growth rate, and the subsequent calculation of stresses taking into account the elastic work of the material.

**Figure 4. Testing of a core sample using a universal testing machine MIM.4-1000.**

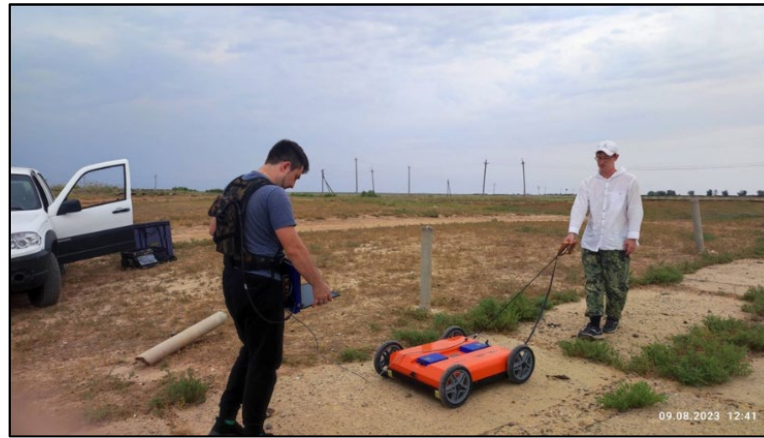
**Figure 5. The GPR survey.**

Both antennas of the device are shielded, which prevents electromagnetic radiation from entering the upper half-space of the device, and suppresses reflection from objects of the upper half-space [25]. The 150 MHz antenna probes the soil to a depth of up to 12 m with a resolution (minimum size of detectable objects) of 0.35 m. The 400 MHz antenna provides probing to a depth of 5 m but with a more accurate resolution of 0.15 m. In this work, due to the small capacities of the probed soils, the main instrument was the 400 MHz antenna, the 150 MHz antenna served as a control.
