Stress-strain state of seepage-control wall constructed for repairs of earth rock-fill dam

M.P. Sainov, O.V. Anisimov, National Research Moscow State Civil Engineering University, Moscow, Russia	Канд. техн. наук, доцент М.П. Саинов, аспирант О.В. Анисимов, Национальный исследовательский Московский государственный строительный университет, г. Москва, Россия	
Key words: earth-rockfill dam; cut-off wall; dam failure; soil subsidence; stress-strain state; clay-cement concrete; seepage load; bored piles	Ключевые слова: каменно-земляная плотина; стена в грунте; авария плотины; просадки грунта; напряжённо-деформированное состояние; глиноцементобетон; фильтрационная нагрузка; буронабивные сваи

The study was conducted on the example of Kureyka HPP dam. Kureyka HPP earth rock-fill dam was constructed in 1980-s on the Kureyka River in Russia's Far North [14].

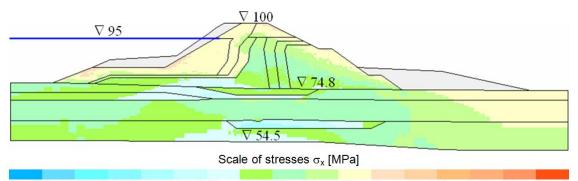
Figure 8. Structure vertical displacements occurred during construction and reservoir filling

By the results of computations the dam has complicated SSS. Before development of emergency situation the dam SSS was considerably subject to soil foundation deformations. Under the dam dead weight and hydrostatic pressure on the apron the dam foundation settles and expands in both sides (Fig. 7, 8). The greatest settlements (56 cm) of foundation occurred under the apron, near the core (Fig. 8). In this zone the dam settlements also reached the maximum values (60 cm). The core settlements are more considerable than those of the shells.
