## Flange connections with high-strength bolts with technological heredity of bolts

**N. Vatin<sup>a\*</sup>, R.G. Gubaydulin<sup>b</sup>, A. Tingaev<sup>b</sup>**

**Abstract.** Tubular truss and column members with bolted connections widely used in construction. The object of this research was the flange joint of a truss bottom chord. The flange joint coaxially connects two cold-formed closed welded rectangular hollow section profiles. The flange connects with high-strength bolts of strength class 10.9. The stress-strain state of the joint was numerically and experimentally investigated. Experimental studies were performed on a full-size sample of a flange joint using strain gauges. Numerical calculations were performed at ANSYS. The bilinear isotropic hardening model simulated the metal elements performance of the joint. The “Frictional” model was chosen for the friction forces between the flanges. The microstructure of the bolt material was studied using an optical microscope. The study results showed that the model solution for a flanged provides a uniform distribution of stresses at the junction due to its spatial rigidity. The presence of stiffener ribs provides the absence

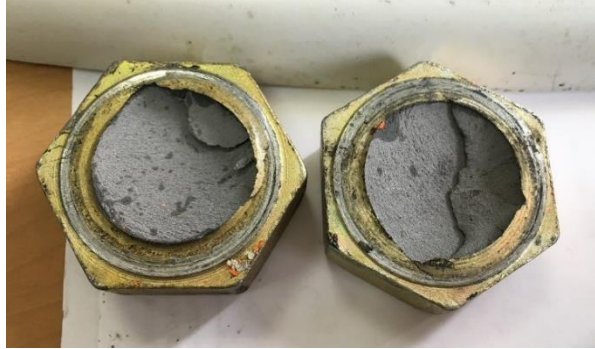
Fig. 19 shows a photograph of the fracture surfaces of bolts M30-6gx160 of strength class 10.9 made of steel 40X. The destruction occurred as a result of the separation of the heads in the process of tensioning the bolts with a force less than the designed.

**Figure 19. Fracture surfaces of severed bolt heads.**
