Research article

## Construction of coconut shell column for the enhancement of expansive soil

**Abstract.** The authors used the crushed coconut shell to make granular columns which were obtained from the market area of Kuantan, Pahang. The coconut was crushed into a similar size of coarse aggregate for the replacement of non-renewable resources like sand and gravel. From its general properties, a coconut shell is hard and can withstand a certain value of exerted value regardless of compression or tension. Besides, the coconut shell is an agricultural product and is found abundantly after human consumption. For this research, the stone-column method was used. The installation of a single coconut shell column was implemented through the Vibro-replacement technique on the soft clay soil. Before accessing the shear strength parameters, the evaluation of the physical and mechanical properties of coconut shells and kaolin was executed via the appropriate geotechnical laboratory approaches. The shear strength parameters were analysed with the control and reinforced specimens through the Unconfined Compression Test (UCT). For the shear strength value, the average value from 4 specimens

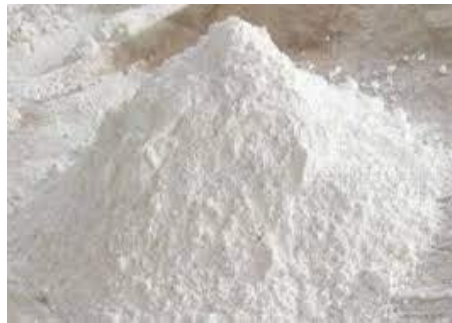
**Figure 1. Kaolin clay S300 [22].****Table 2. Properties of kaolin clay S300 [32].**

In this research, the vibro-replacement method as a ground improvement method was first determined after considering the estimated amount of materials to utilise and the restricted condition, small-scale laboratory test. The primary material of the study, Kaolin Clay S300 which was purchased from Kaolin (M) Sdn. Bhd, Selangor, Malaysia. The main intention of Kaolin Clay S300 selection was due to its natural properties, where it can easily be broken when in contact with the hydrogen ( $H^+$ ) and hydroxide ion ( $OH^-$ ), and it is a hydrophilic substance [31]. It was made available in powder form and white as shown in Fig. 1. This material was used for the column preparation and the nature properties of this material show that it was suitable to meet the research objective as shown in Table 2 [32]. The analysis showed that it comprised silt and clay, with no sand content and thus, it can first be classified as fine aggregate. Besides, the reinforcement material, coconut shell was selected as it met the requirements of being a granular-type material. A typical coconut shell is tough and hard to withstand physical loading, with a shell thickness of approximately 2–8 mm [33]. From Table 3, it was crucial to notice the natural moisture content of a coconut shell was low having a value of 4.20 % therefore can be a potential material to reduce the effect of water accumulation in kaolin clay. It was taken from Kuantan, Pahang, and then processed by grinding it in a machine into small pieces.

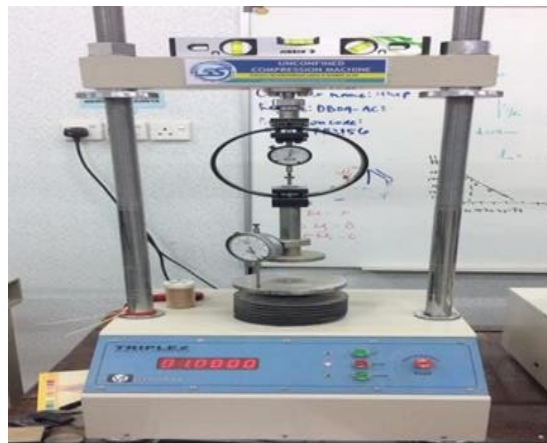
**Figure 3. The specimen was compressed under UCT machine.**

The second objective was based on the UCT based on ASTM D 2166 by exerting the axial compression from the top towards the specimen at a constant deformation rate as shown in Fig. 3. Before conducting the UCT, the crushed coconut shell column was properly designed by considering the column parameters as well as the sieve size of the coconut shell. The column parameters which included column penetrating ratio ( $H_c/H_s$ ), column height to column diameter ratio ( $H_c/D_c$ ), and volume replacement ratio ( $V_c/V_s$ ) were tabulated in Table 4. The granular column which was made up of crushed coconut shell, was split into the partially penetrated column and the fully penetrated column. Besides, the  $D/d$  ratio which indicated the Diameter of the column,  $D$  divided by the Diameter of the crushed coconut shell,  $d$  was also determined beforehand so that it was compared with another set of data. A similar study that used the polypropylene (PP) columns as reinforcement with the  $D/d$  value of 8.47 and 13.55 recorded shear strength improvement [22]. In this study, the  $D$  value was fixed at 14 mm, and the  $d$  value used in was 2 mm thus producing the ratio of  $D/d$  was 7. After several considerations and calculations, the detailed arrangement of the column built within the 50 mm kaolin column was drawn and illustrated in Fig. 4.
